EVALUATION OF PRECISION APPROACH PATH INDICATOR (PAPI)

DOT/FAA/CT-82/153  
DOT/FAA/RD-82/85

# Evaluation of Precision Approach Path Indicator (PAPI)

Final Report

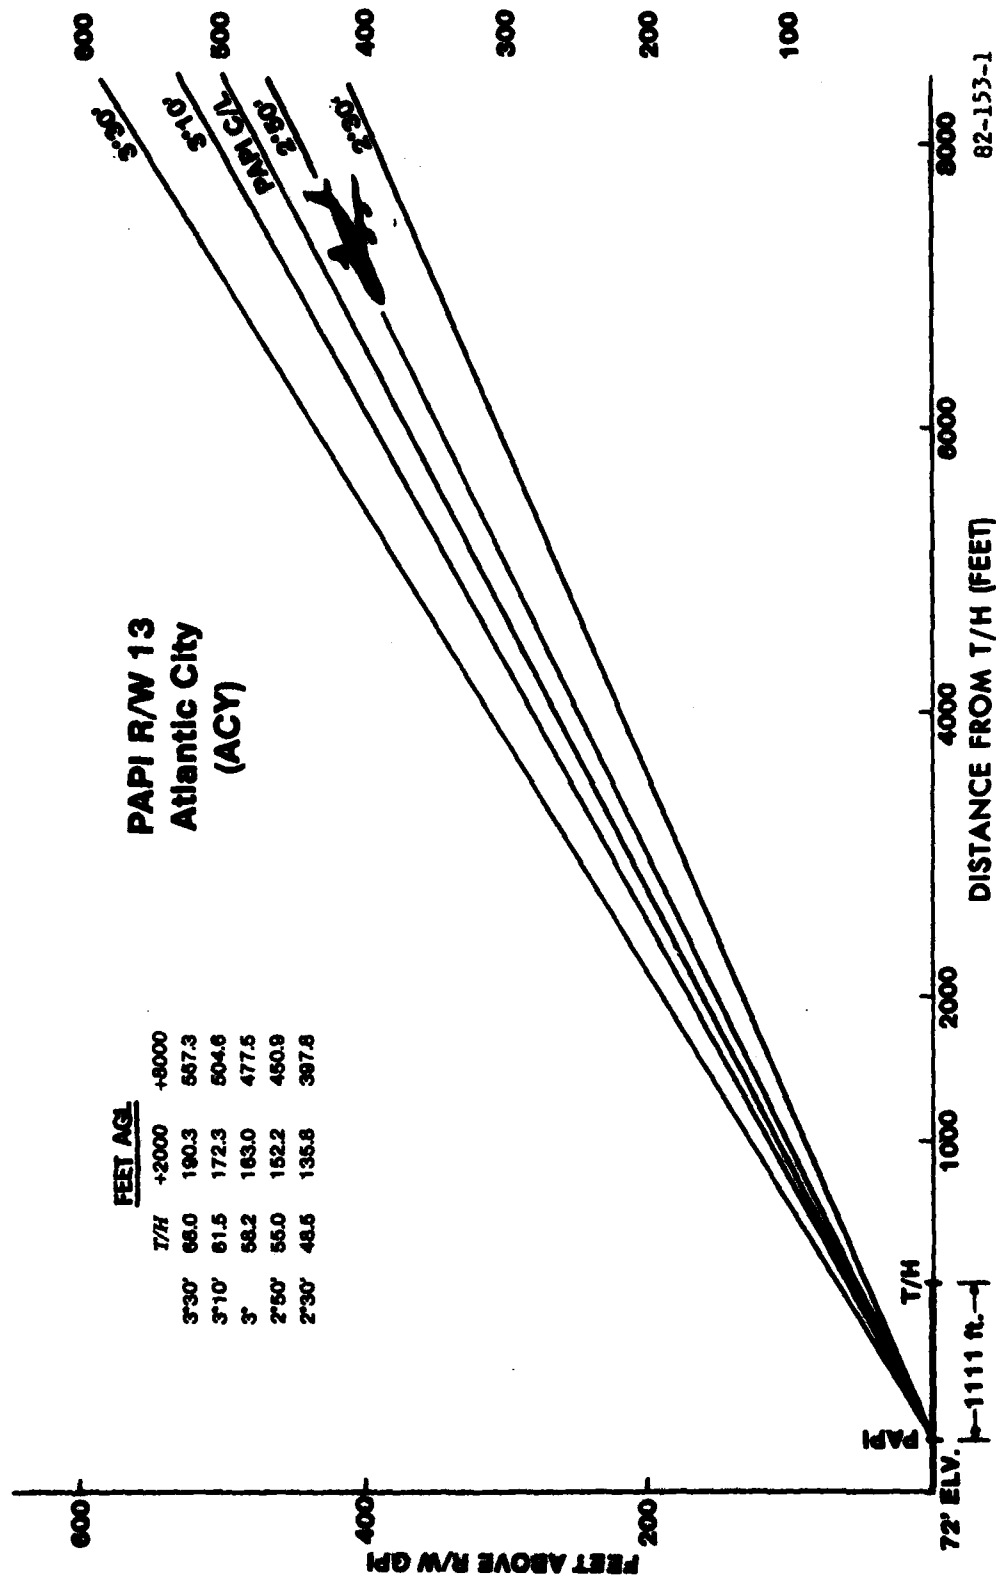
FIGURE 1. PAPI APPROACH PATH (SIDE VIEW)

The PAPI system consists of a bar of four light units (three lamps per unit) facing the approach end of the runway. Each unit is set at a slightly different angle (20 minutes apart) and emits a beam of high intensity light, the upper half showing white and the lower half showing red. Figure 1 depicts a side view of the signal sectors in the approach zone. As seen by the approaching pilot, it consists of a bar of four quick transition red/white light units whose on-glidepath signal (usually 3°) is two red and two white lights (figure 2). When the aircraft is slightly below glidepath (between 2° 50 minutes and 2° 30 minutes), the signal changes to three red and one white light. When the aircraft is further below glidepath (below 2° 30 minutes), a fly-up signal of four red lights is seen. Conversely, deviations above the glidepath will cause the red light units to turn successively white. In this configuration, the lights can be seen at about 5 miles from the threshold of the runway (in unlimited visibility) and the on-glidepath signal depth gradually reduces to approximately 6 feet at the threshold.

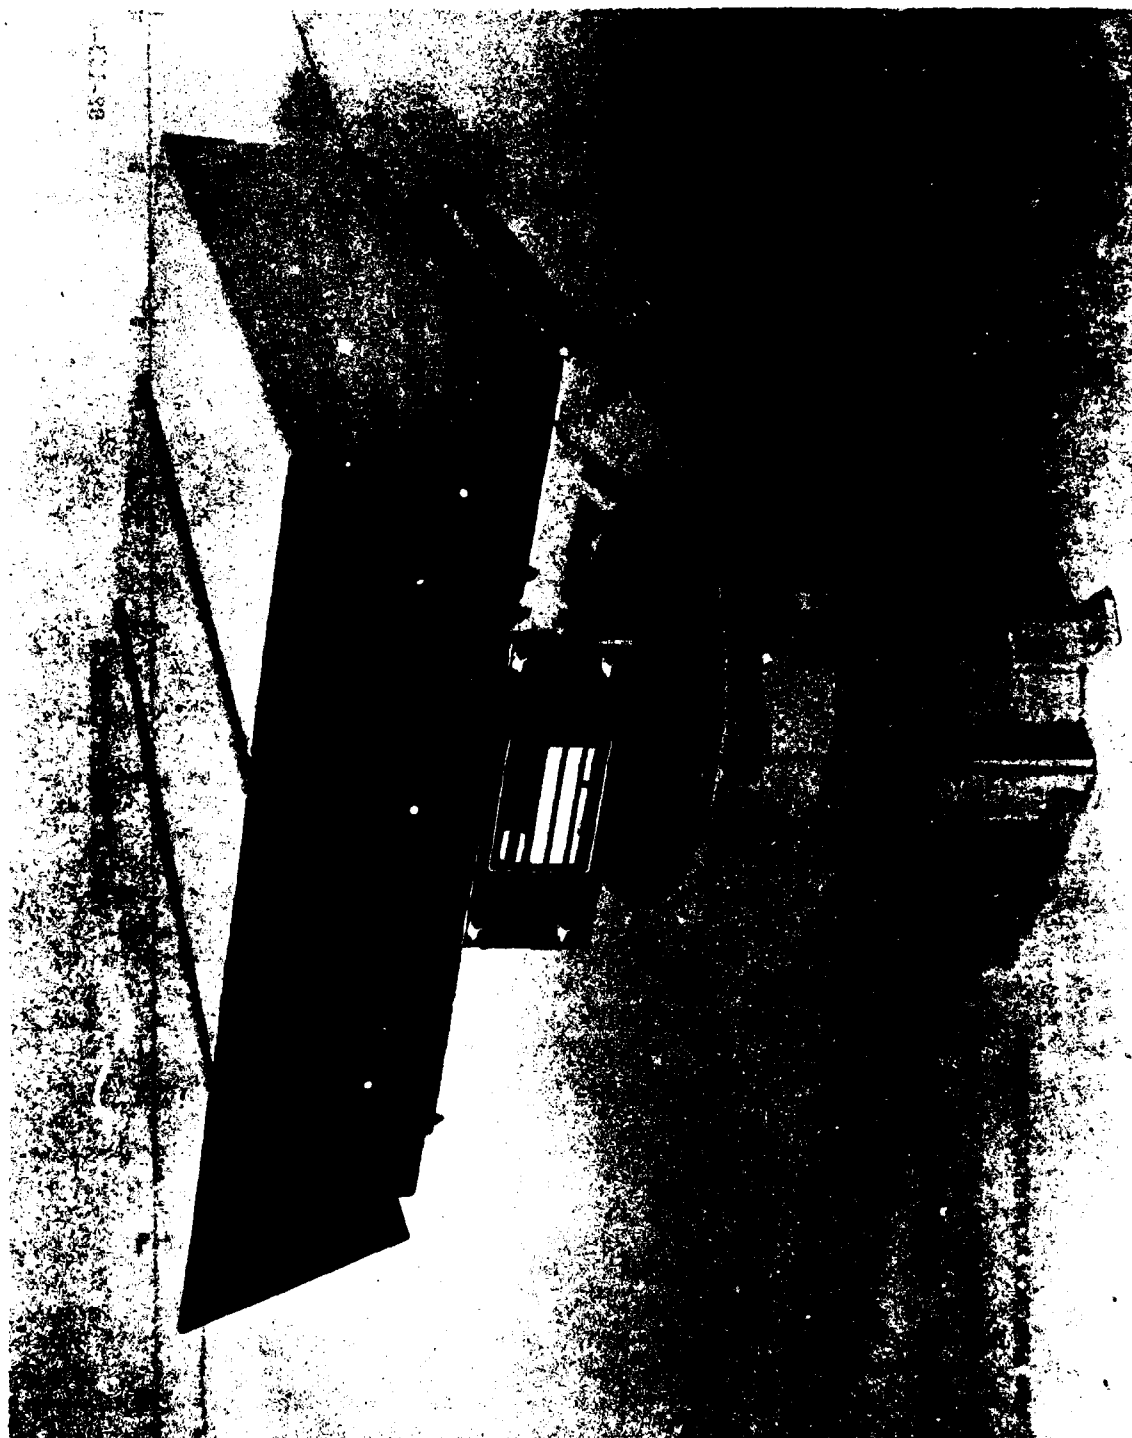
FIGURE 5. CROUSE-HINDS PAPI UNIT

versions of PAPI units built by ADB of Belgium and by Crouse-Hinds, Syracuse, New York (figure 5).

This freezing condensation problem is recognized by the manufacturers and the Barrel units have heaters installed close to the lenses in an attempt to prevent this condition. The Crouse-Hinds units are extremely compact and the heat from the lamps develops quickly to eliminate this condition within a few minutes after energization. Because this problem can be expected to occur with any PAPI unit, specifications should be written to include means for preventing such an occurrence.

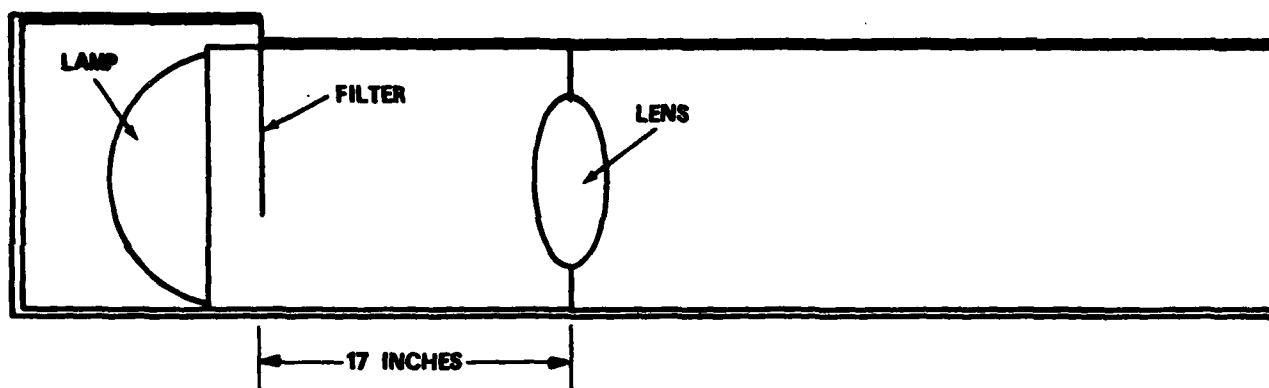
OPEN SLOT MODEL

The "open slot" model mounting arrangement of the optical components included unfluted red filters in their normal mounting positions, with the 6-inch lenses mounted at the focal length, 17 inches forward of the red filters. The normal 2-inch slotted front face of the VASI box was completely removed, leaving the front of the box open.

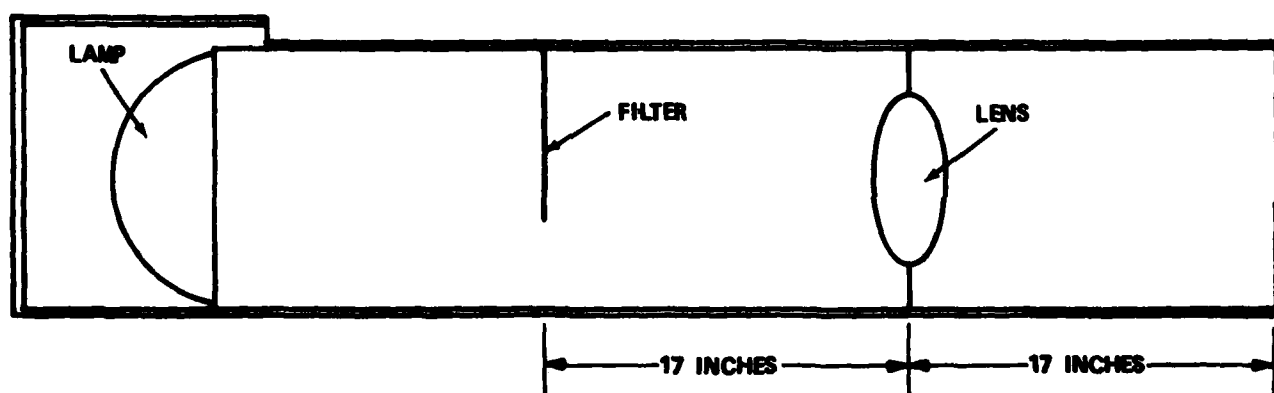
NARROW SLOT MODEL

The "narrow slot" model design required that the 6-inch lenses be moved forward so that the focal length plane was coincident with the normal 2-inch slot on the front of the box to insure maximum signal emission through the 2-inch slot. The lens,

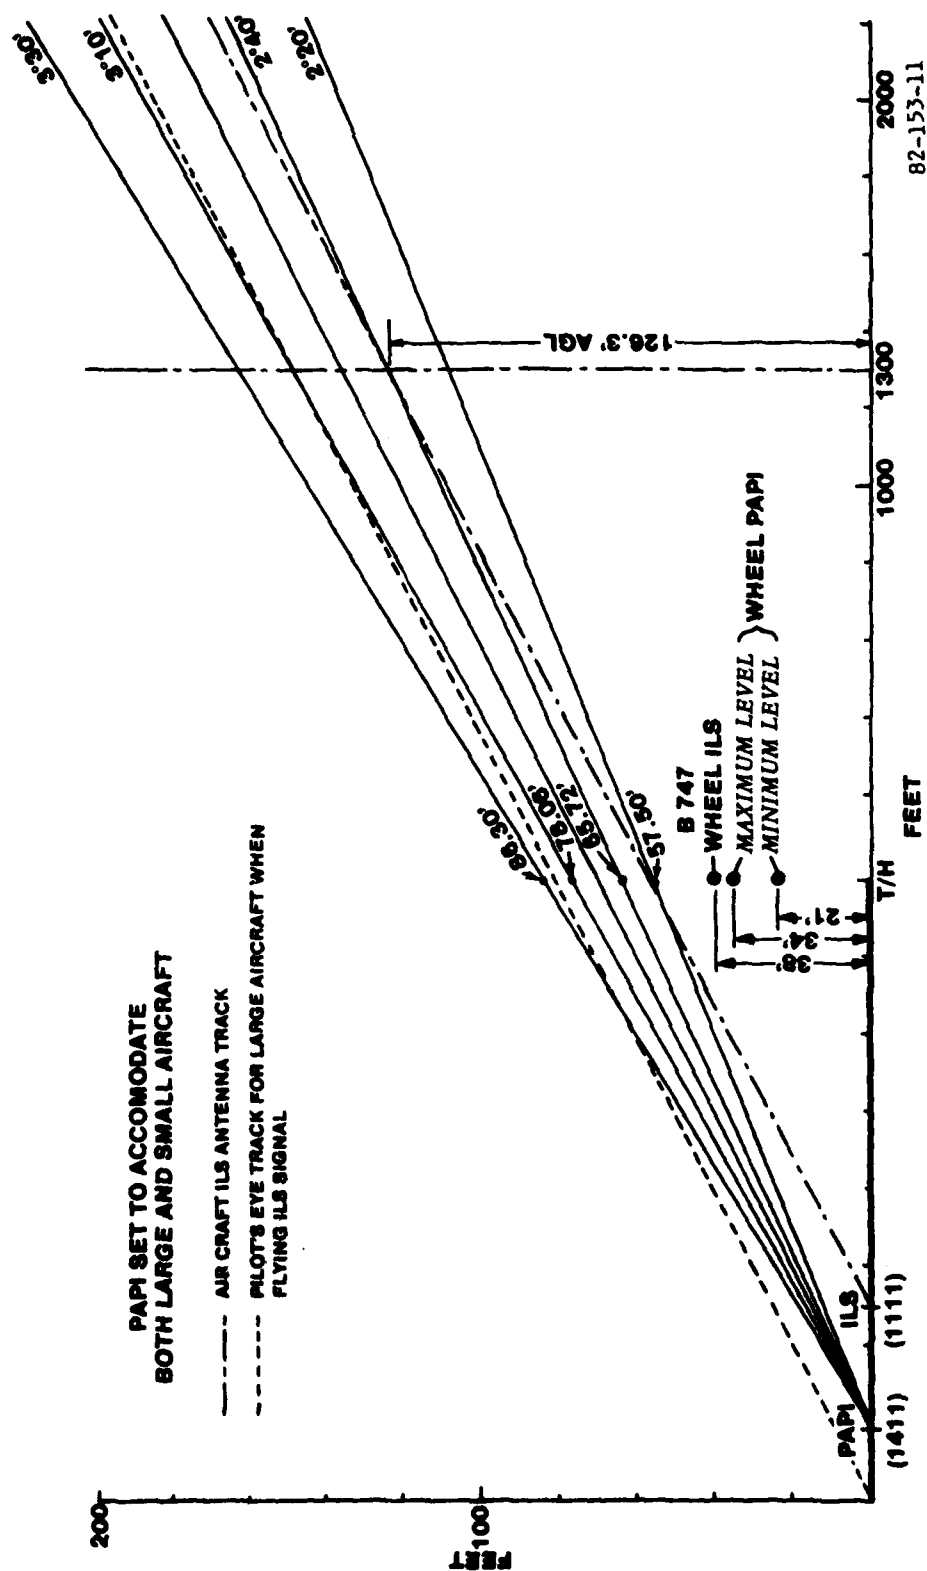
FIGURE 11. TYPICAL PAPI APPROACH PATH WITH ILS

During the flight testing at the Technical Center, pilots were instructed to disregard ILS glide slope indications and to derive vertical approach slope guidance from the PAPI visual presentation only. In fact, during October 1980, 32 special flights were made with the ILS system in the aircraft turned off during the approach phase of flight. No significant differences were noted in the results of this portion of the flight testing as compared to tests where the ILS avionics was operated.

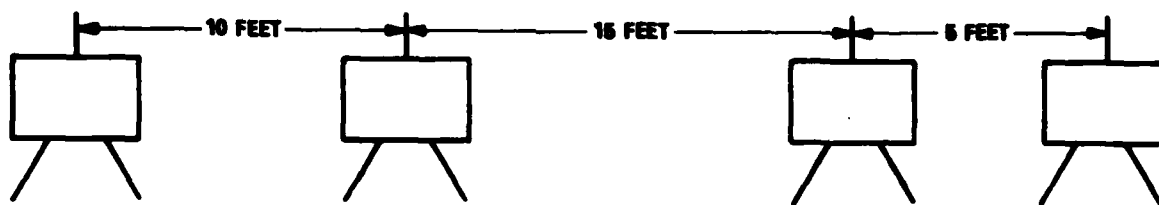
Additional flight testing was conducted to determine whether PAPI signals could be readily seen and resolved with individual PAPI units installed closer together than specified by the British (minimum spacing of 33 feet). Four Barrel PAPI units were installed at the Technical Center in the configuration shown below.

The spacing of the experimental arrangement was so constituted that individual pairs of units could be energized, in turn, to provide lateral spacings of 5, 10, 15, 20, 25, and 30 feet as desired. Approaches were flown, from extreme range, with an Aero Commander 680 aircraft, a Bell 206L helicopter, and a Sikorski S-76 helicopter to determine the maximum distances (range) at which signals from two PAPI light units could be resolved and identified as two distinct light sources. Known landmarks on the ground and distance measurement equipment (DME) in the aircraft were used to observe and record maximum resolution ranges for pairs of PAPI units with lateral spacings as indicated above. A conservative approach was taken in this test and resolution ranges were not established until the lights were judged to be sufficiently distinct so as to insure that an unfamiliar pilot could clearly determine that individual lights from the PAPI system could be seen separately. The flight tests were conducted in VFR weather conditions, in daylight and at night, with at least 4 1/2 nautical miles of visibility.

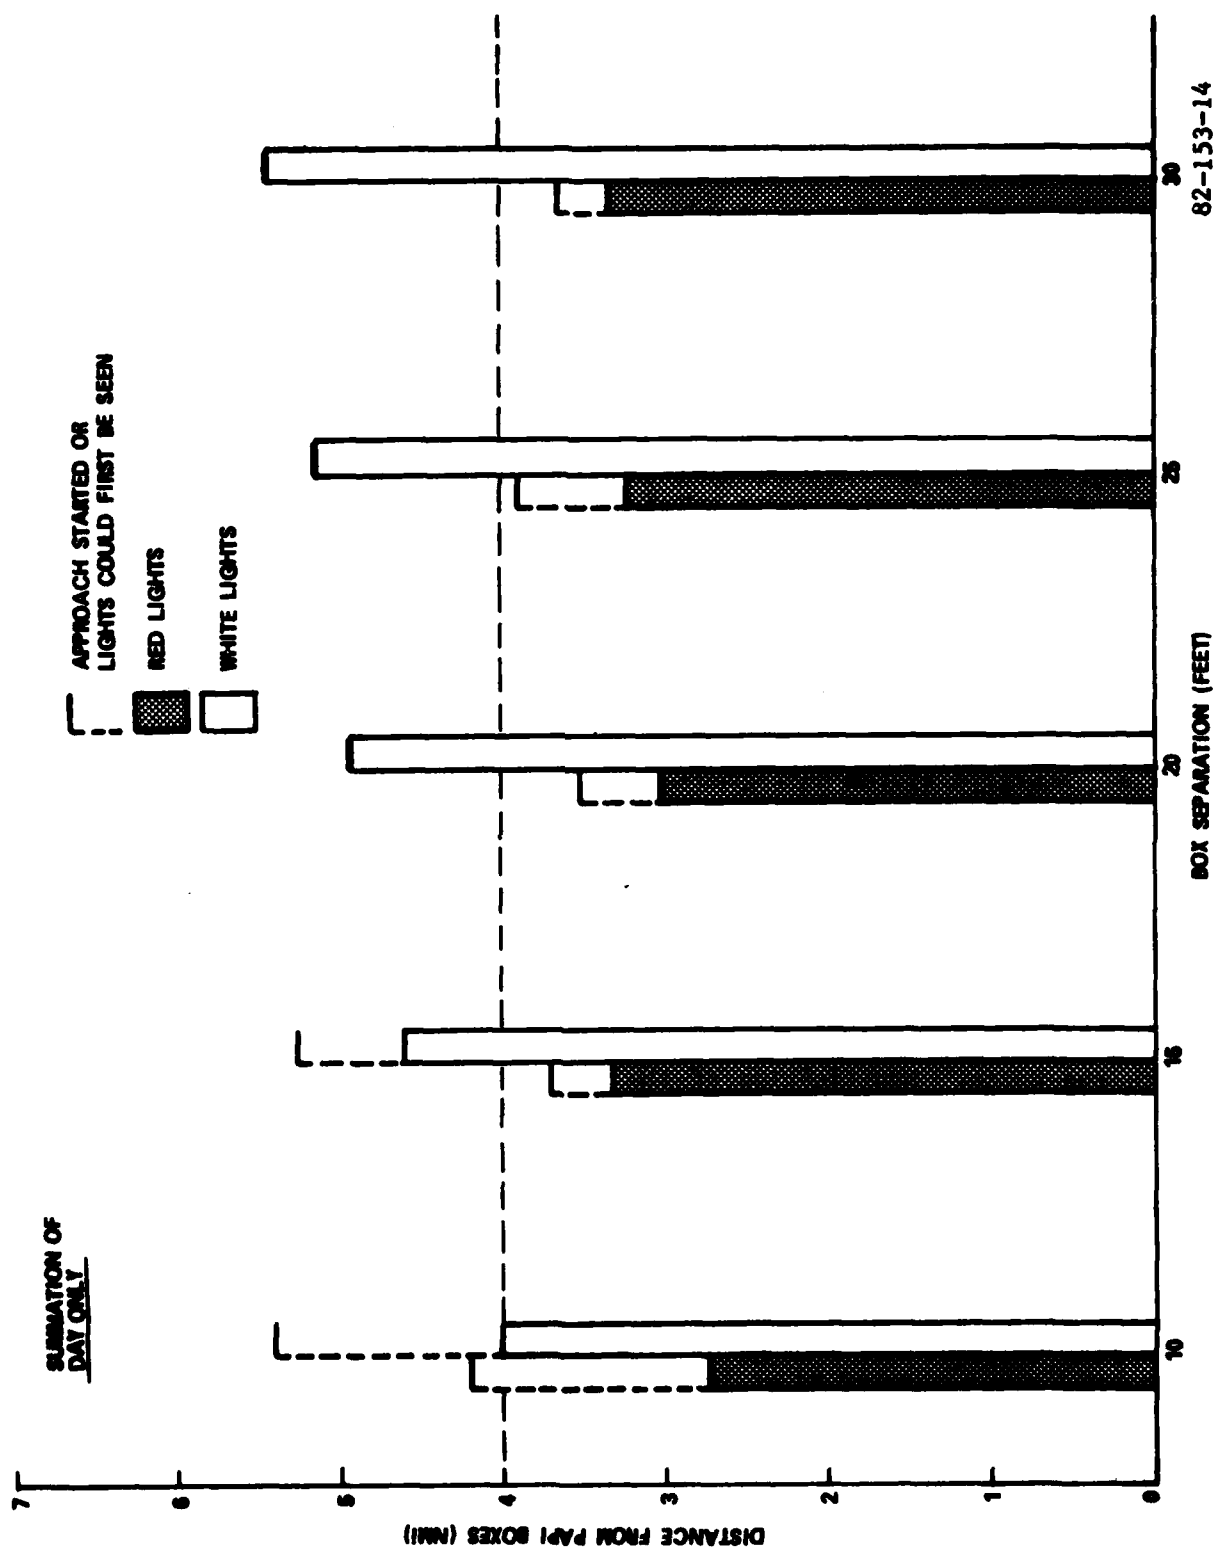
FIGURE 14. GRAPH OF DAYTIME RESOLUTION TESTS

**DAYTIME TEST RESULTS.** (Figure 14). Power supply current, during daytime, was set at 6.6 amperes which is the current value for intensity step 5 on the standard five-step regulator. Pilots were barely able to resolve the PAPI red light signal at 4-nautical mile range with the greatest lateral spacing of 30 feet. In fact, resolution ranges for the red signals were relatively constant at slightly greater than 3 nautical miles, regardless of lateral spacings less than 30 feet. This should not be construed to mean that a full four-box PAPI system could not be used at a 4-nautical mile range, in daylight, since a pilot familiar with the system could easily determine his long range relationship to glide path by counting the discernible white lights of the system.

The average resolution range of the PAPI white lights, during daytime, exceeded 4 nautical miles even when the lateral spacing of PAPI units was as close as 10 feet.

It follows from the above determinations, with regard to both night and day conditions, that lateral spacing of PAPI units installed at smaller General Aviation airports could be reduced to as little as 10 feet and still provide adequate guidance within ranges of 2 to 3 miles from the runway threshold.

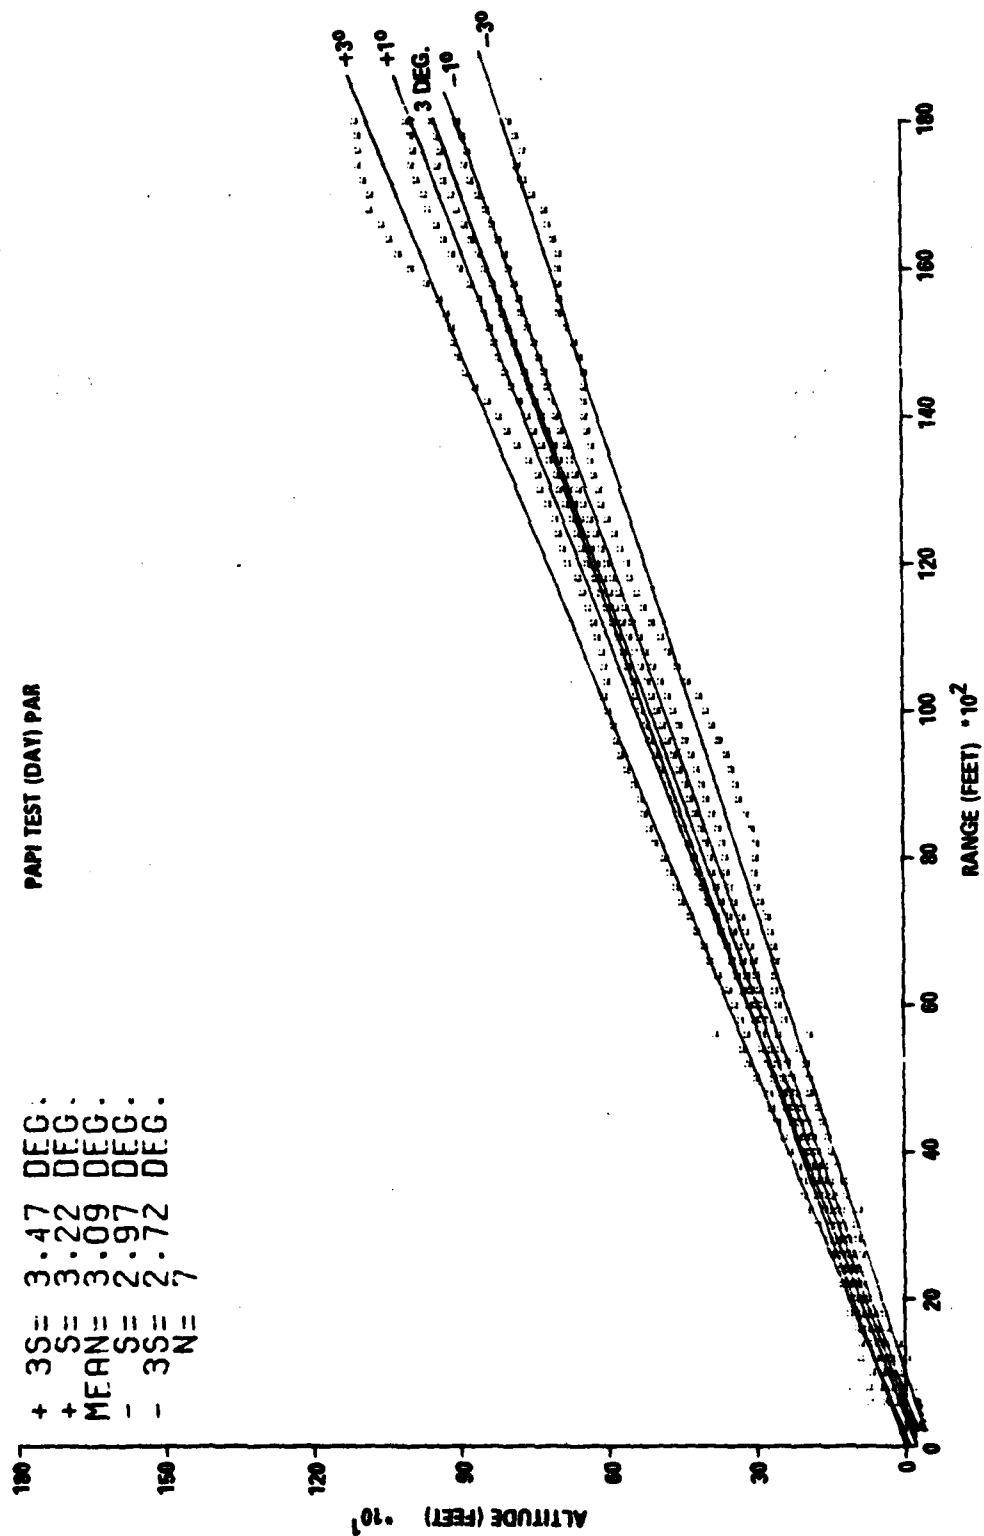
FIGURE D-5. PAPI STATISTICAL DAY PLOT

Attached as Appendix I is a compilation and summary of the data results of the questionnaires obtained from the test pilots during these tests. Also included are composite graphs, separated into daytime runs (figure 3) and nighttime runs (figure 4), showing the accuracy of the system as obtained by Radar tracking and reduced by our computer system. A statistical plot in figure 5

provides a graph that is broken down into 200 foot segments of range. Each range segment, when drawn together, provides a linear regression line. Lines representing the  $\pm 3 \sigma$  deviation indicate that 99.74 percent of all aircraft flying the PAPI would remain within this corridor. The data obtained is offered without comment for this data report. Further testing of this type is planned and will be included in the final report of PAPI.

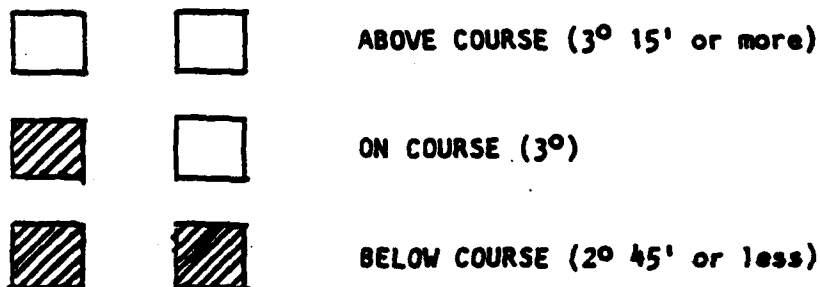
The tests now being conducted will provide data to determine whether a "Two Box" PAPI system can be successfully used on small airports with runways of 5,000 feet or less. The intended purpose of the "Two Box" PAPI is for use where it may not be necessary to have the five incremental paths provided by the full blown PAPI system. The arrangement of the units is similar to the full blown PAPI system except that only two boxes are used. The  $3^{\circ}$  glide-slope is midway between the angular setting of the pair of light units. The on-course signal is one red and one white light, the above course (greater than  $3^{\circ} 15'$ ) is two white lights, and the below course (less than  $2^{\circ} 45'$ ) is two red lights. These are depicted in the diagram below.
